BMW
528i, 540i, (1997-2003)
530i (2001-2002)

PART NUMBER: **BM-51-97**

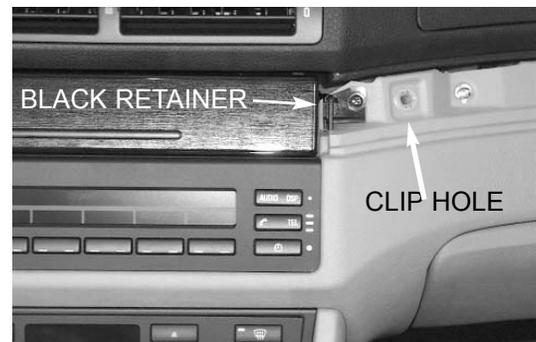
STEP 1.

Begin by removing the wood grain trim panel that is to the right of the radio and above the glove box. To do this: **Carefully** Insert your hook tool in behind the trim panel approximately 2" inch from the left end of the panel on the top side. **Carefully** pull back toward you to release the first clip. Once the first clip is released continue working the panel loose to the right, releasing three (3) more clips. Set trim panel aside.

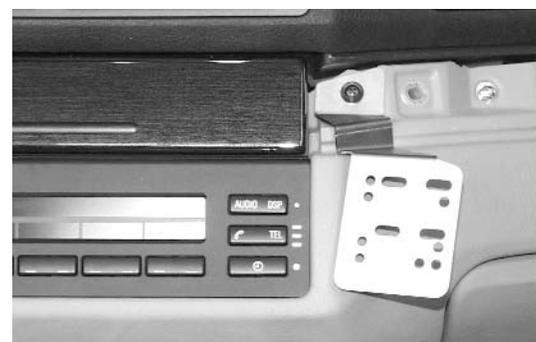
STEP 2.

After the trim panel is removed, you will see four (4) Phillips screws. Remove the first Phillips screw to the right of the radio using your #2 Phillips screwdriver. **NOTE: On some models there will be a black plastic retainer under this screw. Remove the retainer and place it in the glove box. The retainer will not be used in the installation of the Pro.Fit VSM®. Please inform the customer of its whereabouts.** Install the phone holder onto the **Pro.Fit VSM®**. Align the hole in the **Pro.Fit VSM®** with the screw hole and insert the factory screw. Tighten down the mount with your #2 Phillips screwdriver.

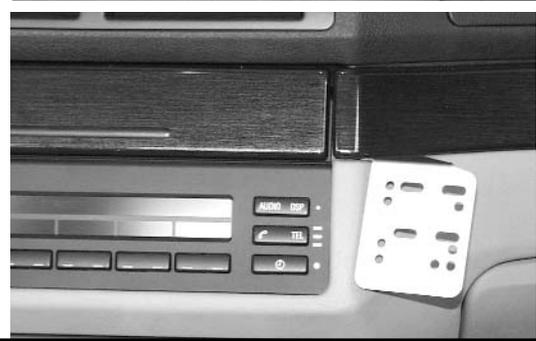
STEP 3.

Carefully replace the wood trim panel securing all clips.

This completes the installation of your **Pro.Fit VSM®**.
